KTM Intermediate Gear Problem - Applies to 2000-2005 Electric Start KTM RFS 250, 400, 450 and 525. Text and Pictures from KTMTALK Members. Post: <u>http://ktmtalk.com/index.php?showtopic=139918</u> Pictures: http://ktmtalk.com/index.php?showtopic=139918&st=60

Problem with my e-start: KTM Intermediate Gear Problem

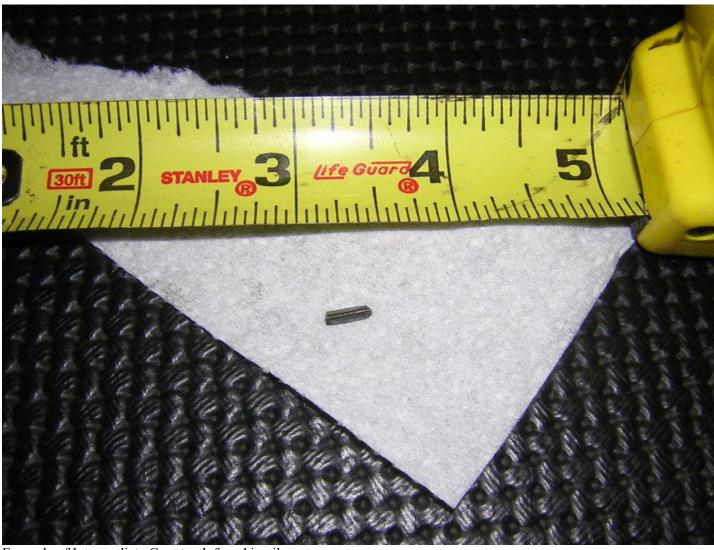
harder gears it still needs to be relieved in someway, thus the new design with torque limiter. Most of the time, the teeth sheared from the intermediate gear will be found stuck to the magnetic drain plug when changing the oil. However they can also get you stuck in one gear or put undue wear on the trans. If you get stuck in one gear out in the middle of nowhere, the trick is to ride it up on a ledge or rock and to can lean the bike over far enough to let the broken tooth fall through to the drain magnet, and the shifter will work to get you back to the truck.

Example of Intermediate Gear tooth found in oil

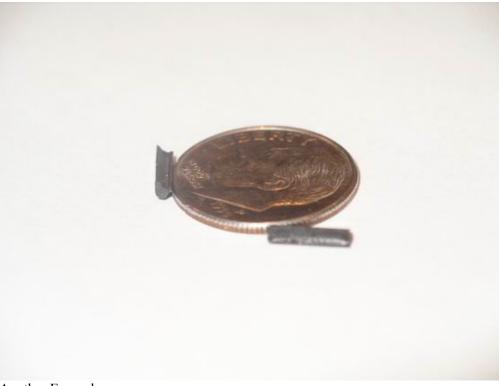
Another Example

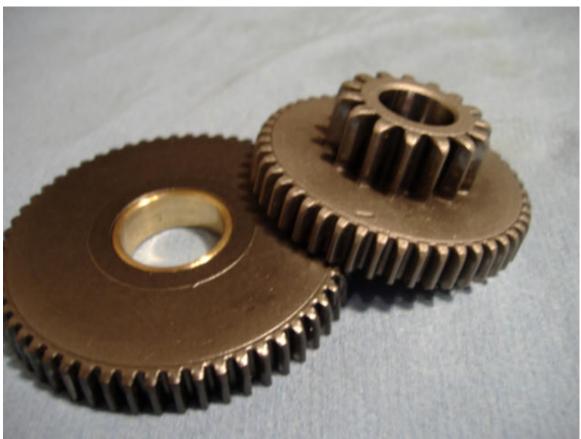
05 and Older Reduction Gear and Intermediate gear

If all your OTHER gearwheels are OK, you may need only the torque limiter. However I would replace the intermediate gear while at it if you still have an original 05 gear.

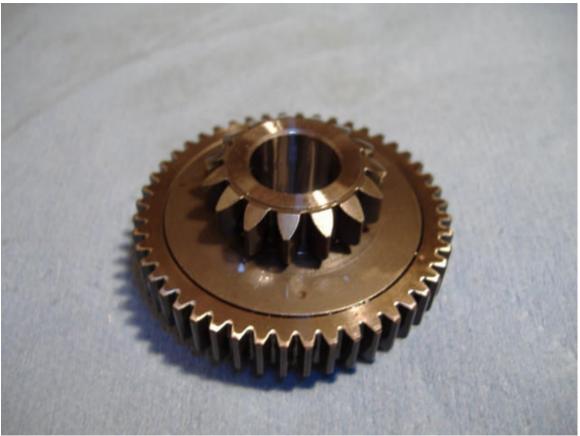
06 New Torque Limiter Inside View - 59040016000 TORQUE LIMITER 06

The 06 torque limiter gear is the part that is different. Rather than the solid reduction gear as before, it is an assembly that can slip, it seems to be "spring" loaded. You need the 2 needle bearings for it, and you will need to order the new 06 case cover or machine a small amount off your case. The new case is .346 from the flat to the edge of the case. The old one is much shorter distance, as it is a taller post. The new case is milled almost flat with the surface of the inner case (See pictures below). It doesn't look very hard to machine the flat down, but its a little more than a dremmel tool job.

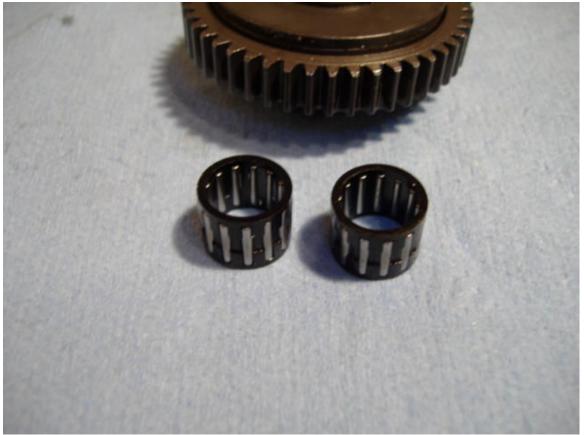
06 Needle Bearings - 0405101310 NEEDLE BEARING

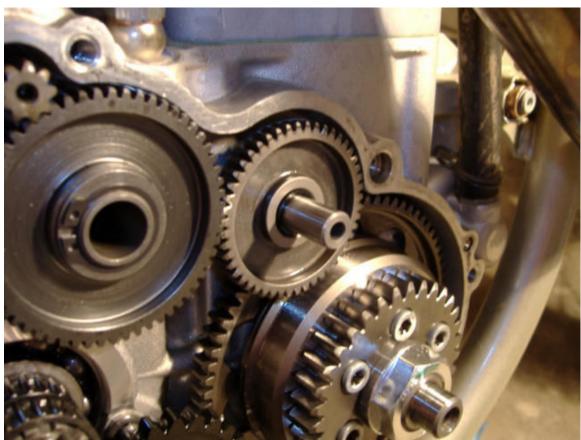
05 and Older Gears Mounted on the Bike

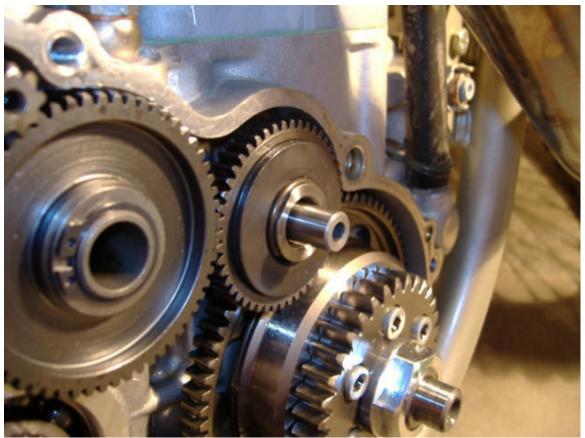
06 Gears Mounted on the Bike. Notice the thickness of the Torque Limiter

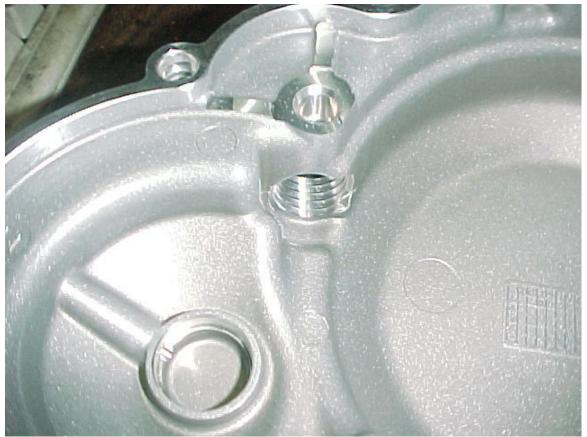
06 Case Cover - 59030001100 CLUTCH COVER RACING 2006

If you get the new 06 clutch cover, you will need to get the seals that are on the inside, there are two of them. The sight glass is easy to get out, just take your time and don't crack the glass. Put gray silicone around the site glass rubber. Wrap the long bolt that goes right above the site glass with a few turns of Teflon tape. If you don't, the oil passage there will allow oil to drip out the bolt head giving the appearance that the site glass is leaking.

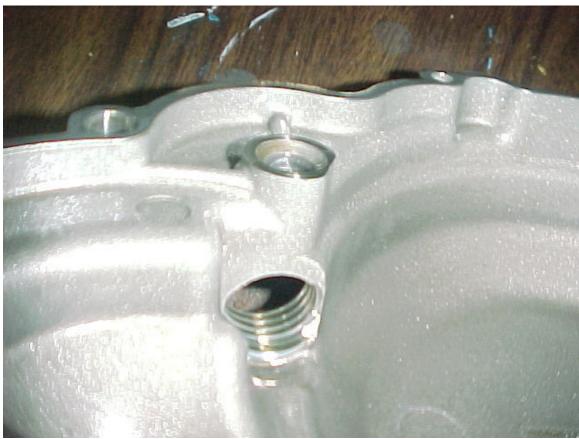
05 and Older Case Cover
